COLUMBIA

ACCIDENT INVESTIGATION BOARD

REPORT VOLUME I
AUGUST 2003

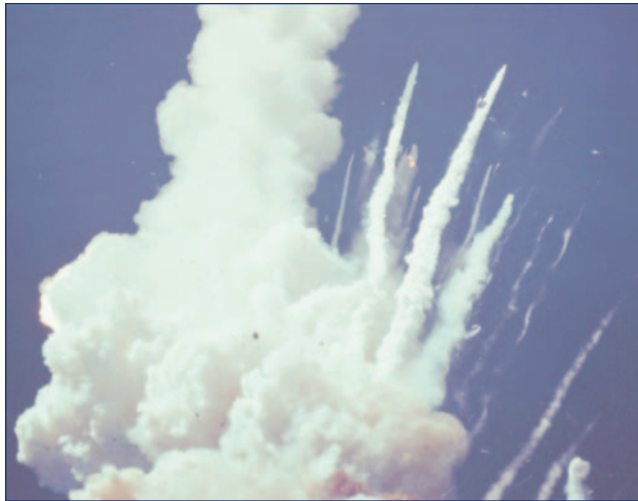
Figure 1.5-1. the Space Shuttle Challenger was lost during ascent on January 28, 1986, when an O-ring and seal in the right Solid Rocket Booster failed.

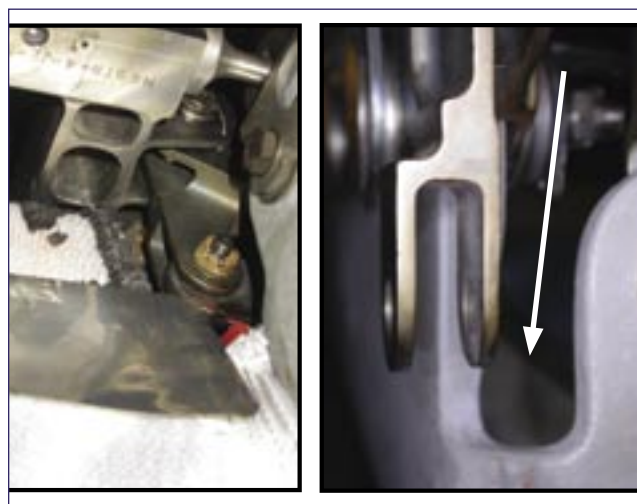
Figure 3.7-2. Each RCC panel has a U-shaped slot (see arrow) in the back of the panel. Once superheated air entered the breach in RCC panel 8, some of that superheated air went through this slot and caused substantial damage to the Thermal Protection System tiles behind this area.

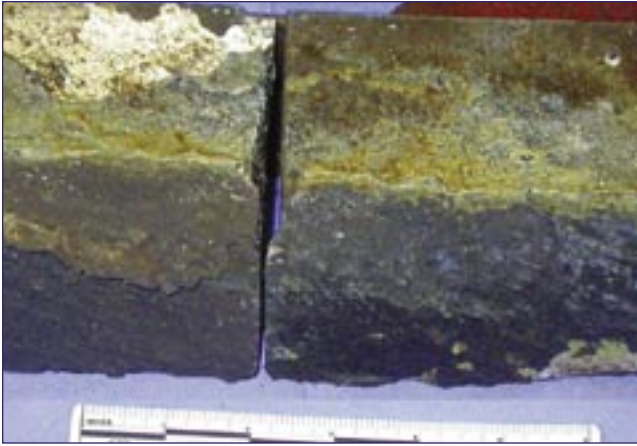
Figure 3.7-3. Superheated airflow caused erosion in tiles around the RCC panel 8 and 9 interface. The tiles shown are from behind the area where the superheated air exited from the slot in Figure 3.7-2. These tiles showed much greater thermal damage than other tiles in this area and chemical analysis showed the presence of metals only found in wing leading edge components.

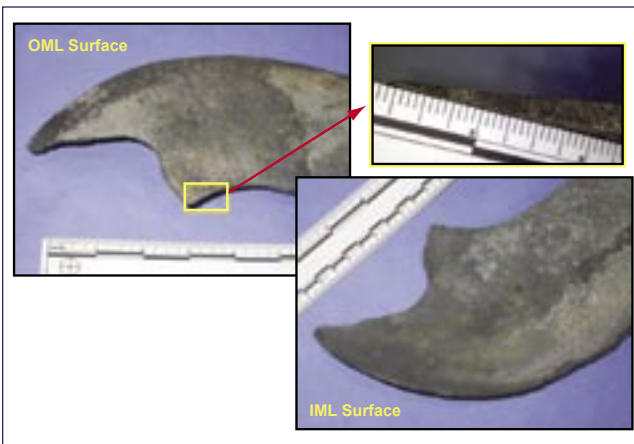
Figure 3.7-4. The outboard rib of panel 8 and the inboard rib of panel 9 showed signs of extreme heating and erosion. RCC erosion of this magnitude was not observed in any other location on the Orbiter.

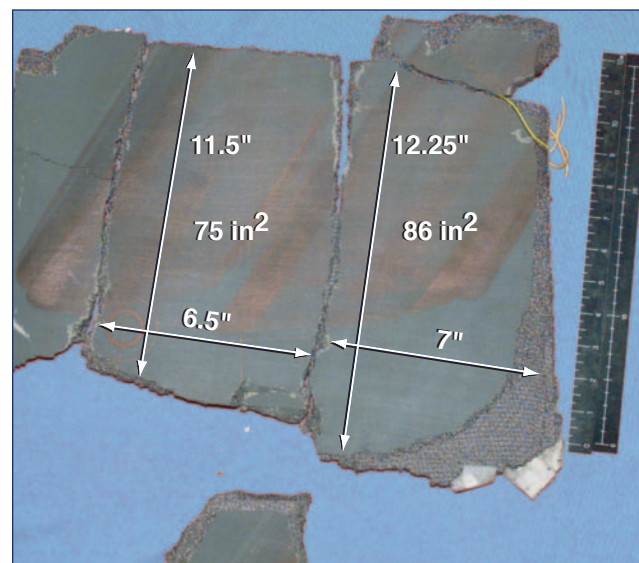
Figure 3.8-11. Three large pieces of debris from the panel face sheet were lodged within the hollow area behind the RCC panel.

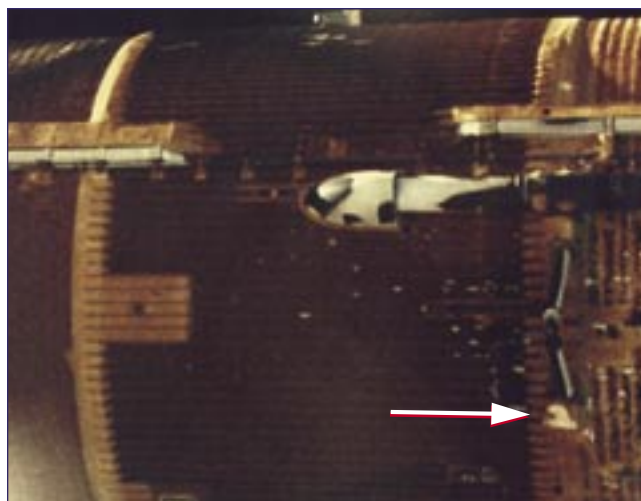
Figure 6.1-2. The first known instance of bipod ramp shedding occurred on STS-7 which was launched on June 18, 1983.

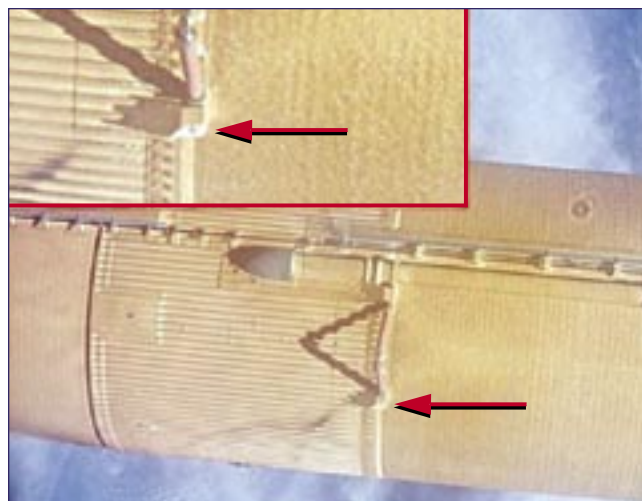
Figure 6.1-3. Only three months before the final launch of Columbia, the bipod ramp foam had come off during STS-112.
